Manhole Inspection Summary

Manhole # S19A1_018MH

Insp Date: **6/2/08 11:55 AM**

Location Address: **1930 carroll st**

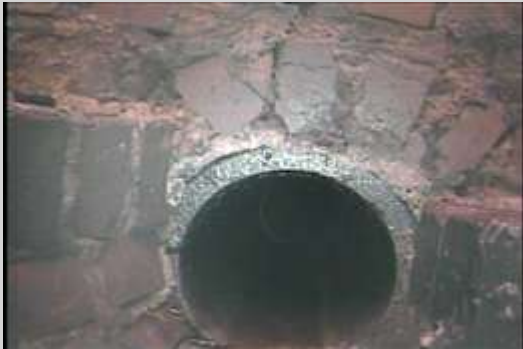
12 O'Clock Outflow

8 in. Circular Gravity Sewer
Pipe Out @ 12 O'Clock

Pipe Height: **8.4** (in.) Rod and Bar (Angled)
Pipe Material: **Clay** ☐ Pipe Lined
Invert Depth: **11.90** (ft.) Flow Characteristics: **Slow**
Deposits: ☒ None ☐ Mud ☐ Sludge ☐ Debris ☐ Grease
Silt Depth: **0** (in.) Deposits Extent:
Infiltration: **None** Pipe Seal Cond: **Sound**

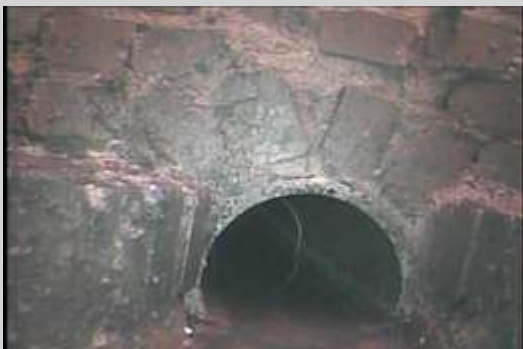
3 O'Clock Inflow

8 in. Circular Gravity Sewer
Pipe In @ 3 O'Clock

Pipe Height: **8.4** (in.) Rod and Bar (Angled)
Pipe Material: **Clay** ☐ Pipe Lined
Invert Depth: **11.84** (ft.) Flow Characteristics: **Slow**
Deposits: ☒ None ☐ Mud ☐ Sludge ☐ Debris ☐ Grease
Silt Depth: **0** (in.) Deposits Extent:
Infiltration: **None** Pipe Seal Cond: **Sound**
